HELICOPTER INSPECTION OF HIGH - VOLTAGE AND MEDIUM - VOLTAGE POWER LINES

R. Glavič, Elektro Ljubljana d.d., Slovenska 58, 1000 Ljubljana, Slovenija

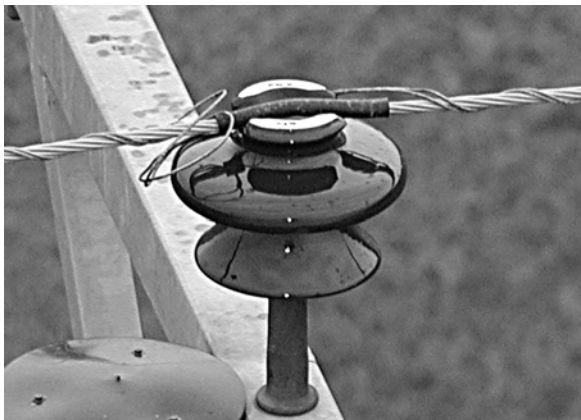
FIGURE 1 - ANOMALY DETECTED BY VIDEO INSPECTION

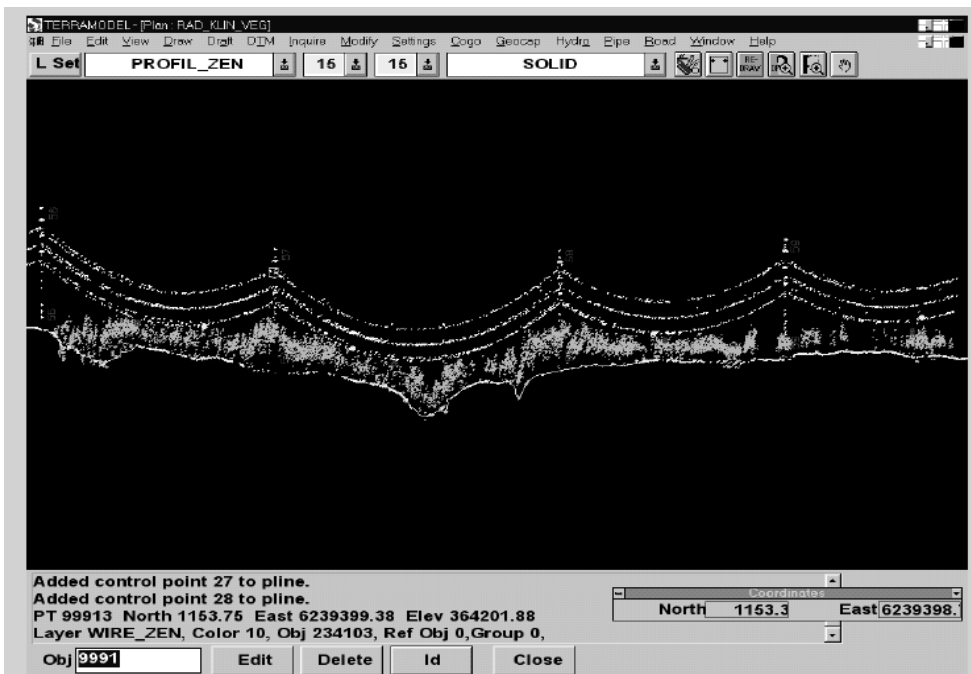
FIGURE 2 - LASER IMAGE SHOWING VEGETATION

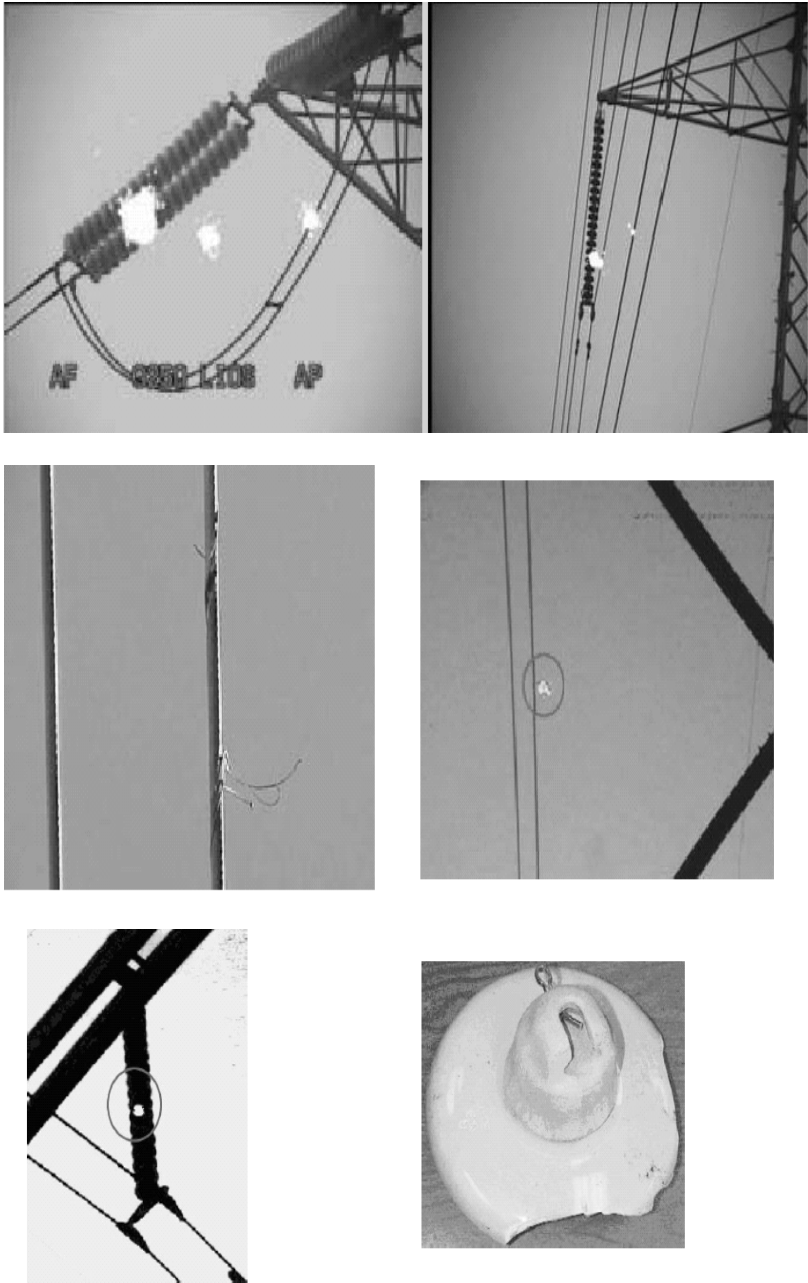
FIGURE 6 - DEFECTS DETECTED BY CORONA INSPECTION

- on all sharp-edged parts of high-voltage equipment due to current conductor's non-uniform cut in making a junction; the cut needs more precise treatment,
- on bolted connections due to the bolts of various lengths,
- on current conductors, because single wires are damaged.
