## **APPLICATION OF THE DIGITAL PROTECTION IN THE TRANSFORMER SUBSTATION 35/10kV WITH ISOLATED NEUTRAL ON THE 10kV SIDE**

S. Cvetković, Elektrodistribucija Beograd, Srbija i Crna Gora  
V. Cvetković, Elektrodistribucija Beograd, Srbija i Crna Gora  
A. Milosavljević, Elektrodistribucija Beograd, Srbija i Crna Gora

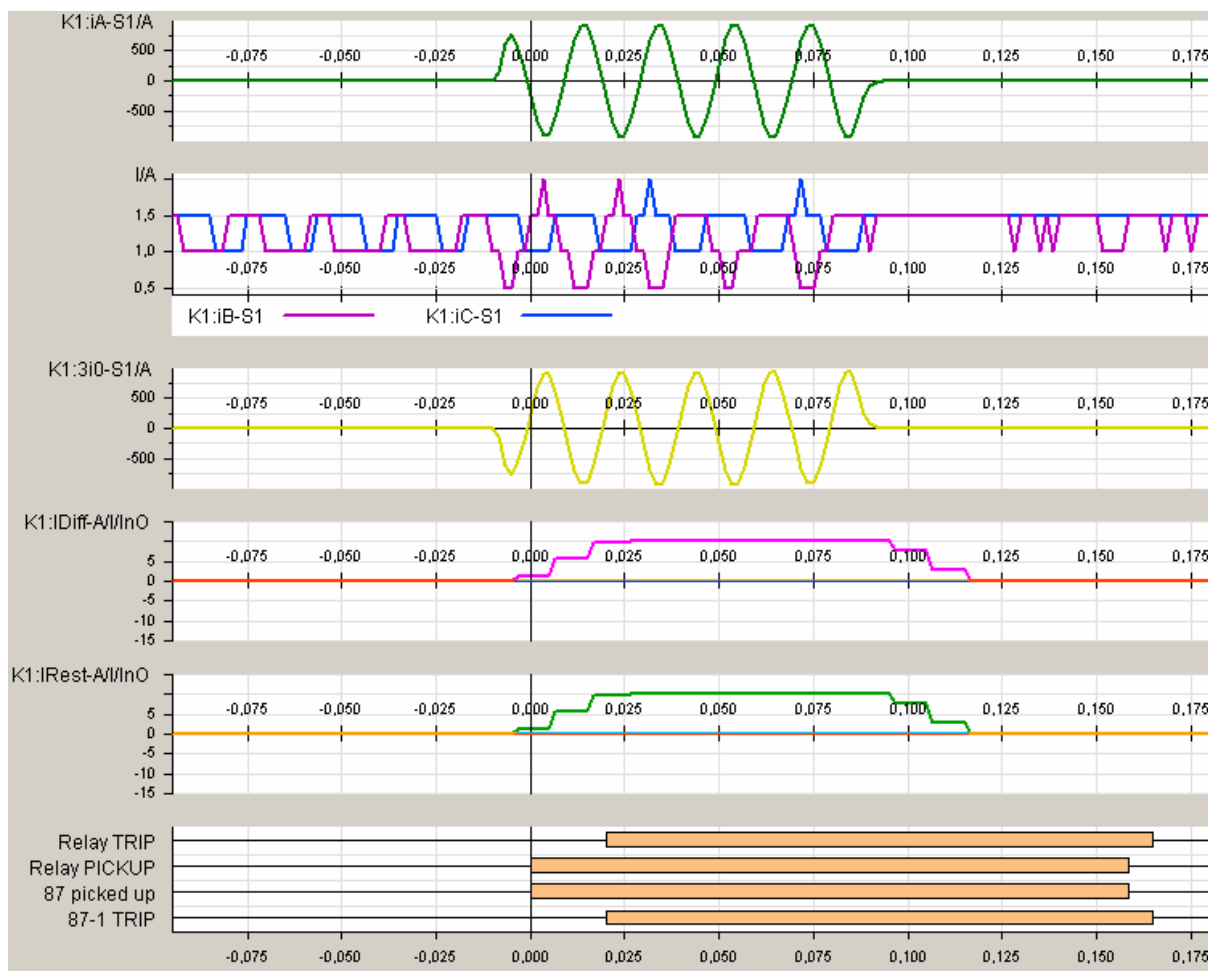
Figure 2: Captured waveforms for the fault on December 20<sup>th</sup> 2003

**Fault in the protected zone.** This fault occurred on the cable end in the phase A of the 35kV transformer bay H01 on December 20<sup>th</sup> 2003 at 15:58. Insulation on the cable end failed and energized cable core came in the contact with grounded cable shield wires. Figures 1 and 2 show record from the trip log and time signals of the fault respectively, downloaded from the differential protection device. On the basis of these records fault has been correctly located before visual inspection.

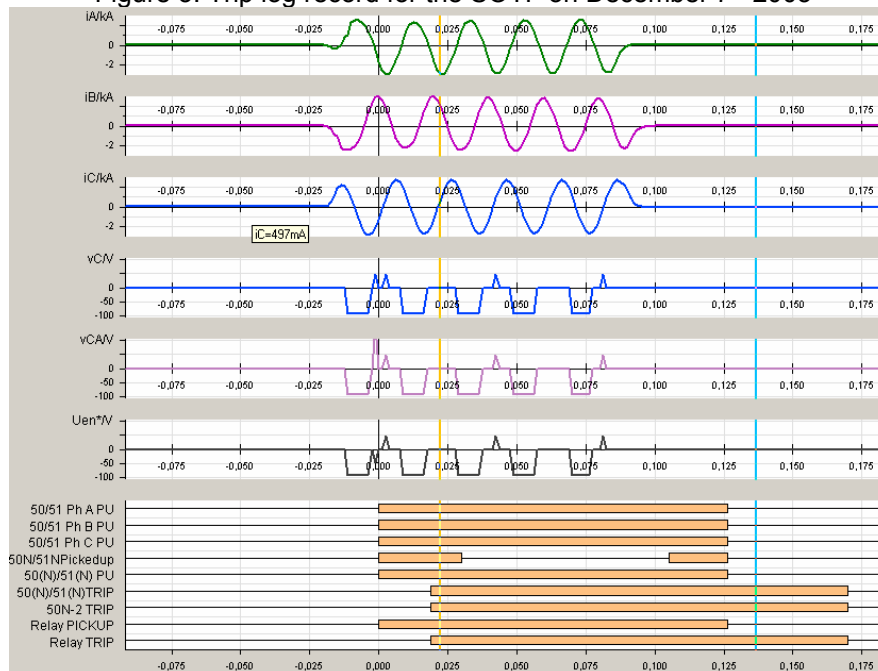
Figure 4: Captured waveforms for the SOTF on December 7<sup>th</sup> 2003

**Switch onto fault.** This fault occurred in the outgoing 35kV bay on December 7<sup>th</sup> 2003. The grounding disconnect switch on the cable end failed mechanically and remained in the grounded position, indicator showing OPEN position at the same time. The circuit breaker was directly closed on the grounded cable. All protections in the 35kV network are with time delays for the purpose of protection coordination. Therefore it can be said that SOTF function in this case prevented occurrence of higher level damage.

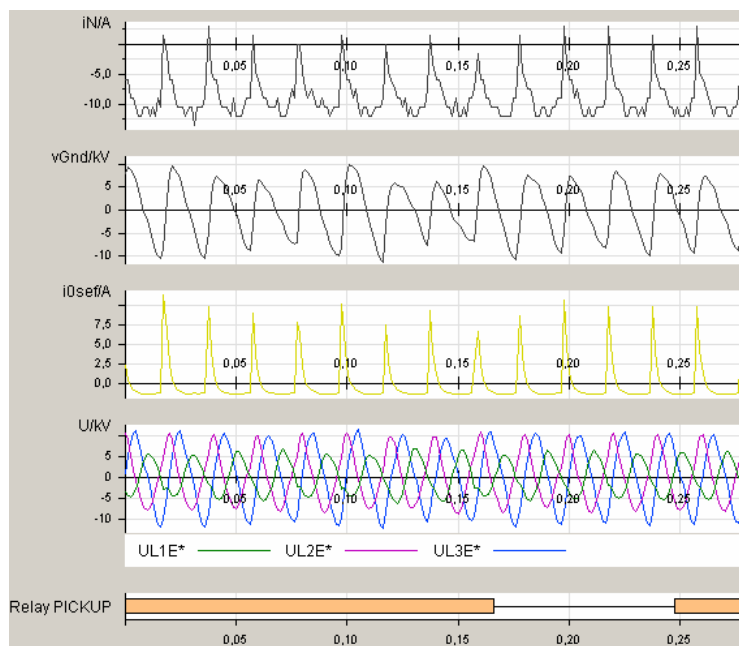
Figure 6: Captured waveforms for the fault on March 14<sup>th</sup> 2004

**High resistance earth fault.** This event occurred in the 10kV transformer bay K04 on March 14<sup>th</sup> 2004. Insulation on the cable end failed and high impedance ground fault occurred with low fault current which could not be detected by the differential protection. Fault was cleared by 64 (displacement voltage) protection after 6 seconds.
