REALISATION OF SAFE ASSEMBLING OF MIDDLE VOLTAGE OVERHEAD POWER LINES WITH COMPOSITE INSULATORS AT CROSSING THROUGH FOREST

Jože Hrastnik, dipl.ing.el.
IzoElektro d.o.o.

Abstract: Report consider designation of dedicated equipment for safe construction of middle voltage free aerial power lines at crossing through forest. It was chosen on base of calculations, laboratory tests and functional confirmation by test in natural environment. Presented way of power lines construction with certain equipment ensures essential decrease of damages on power lines in case of extraordinary weather circumstances.

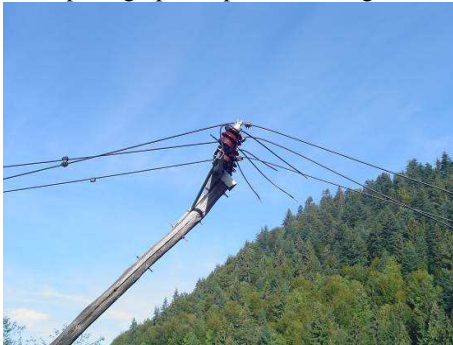
Figure 1: Suspension pole with ceramic insulators.

From 1998 onwards there have been many damages caused by extraordinary weather conditions on overhead power lines which cross through forest. The damage was caused by felling trees, shaking-off snow, sleet and lightning. Consequently the damages on power lines occurred irrespective to equipment that was used. The most common damages are deformation of:

- insulation of SAX conductor,
- cross-arms,
- spring clamp,
- ceramic insulators and
- poles.

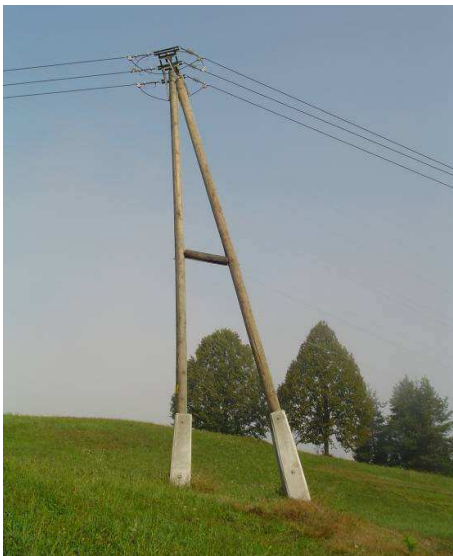
Figure 2: Pulled out tension pole.

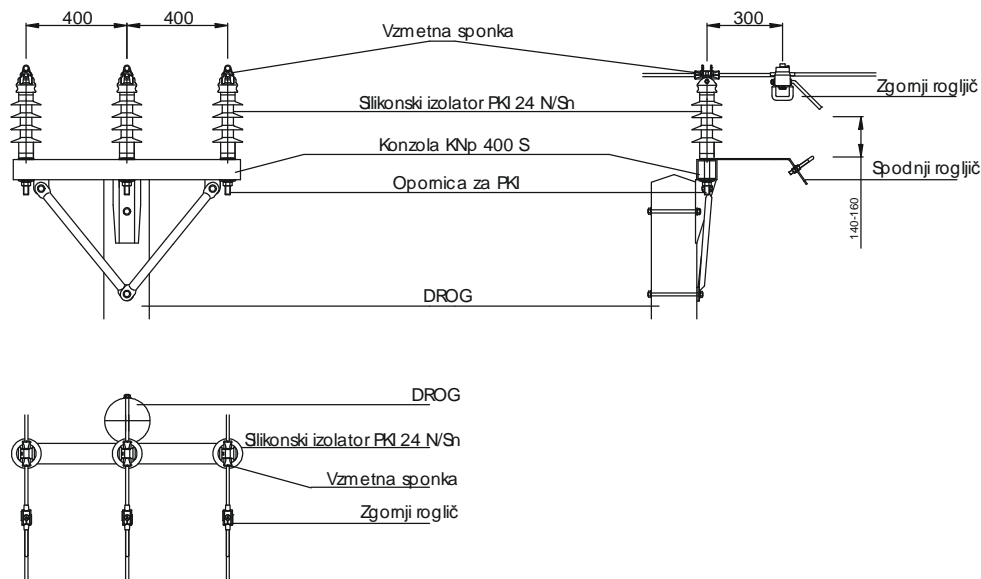
Figure 4: Suspension pole plan

With use of laboratorial determined equipment, the reduction or dispatch of damages on suspension poles is anticipated. At damages, defects should be limited only to special spring clamp that can be replaced fast and easily. To perform a test on the ground (concerning laboratorial measurements) the following items are selected:

- **composite line post insulator with special spring clamp – Figure 3 and 5,**
- **pillar PKI M20/180 – Figure 6,**
- **other equipment specified in the plan.**

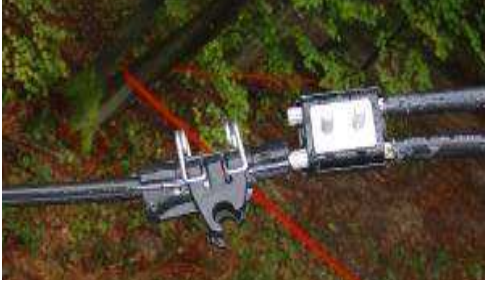
Figure 12: Special spring clamp after test carried out

As anticipated, at tree fall composite line post insulators compensated first thrust due to their elasticity. After that special spring clamp on composite line post insulator (which was built in tension pole) gave in and so disabled tearing of conductor as well as defects on half-insulated conductor insulation. Because of big force safety hooks on tension pole gave in in which caused the extension of safety arc.

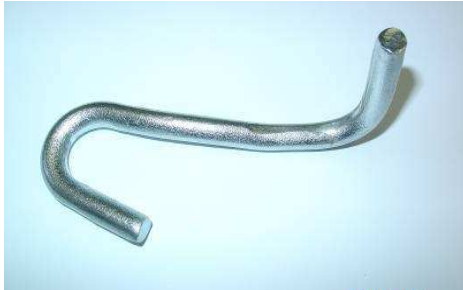
Figure 13: Straightened hook after test carried out.

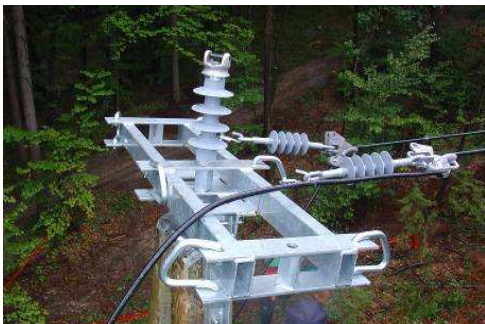
When damages on poles were surveyed, it was observed that poles and cross-arms remained unharmed. Only special spring clamp on composite line post insulator and safety hooks on tension poles would have to be replaced. Poles nb. 6 and nb. 7 were 6° out of vertical position.

Figure 14: Undamaged tension pole.
