## THE PROVIDING AND RESTORATION OF THE POWER DISTRIBUTION IN MAJOR CLIMATIC DISTURBANCES

### **Abstract:**

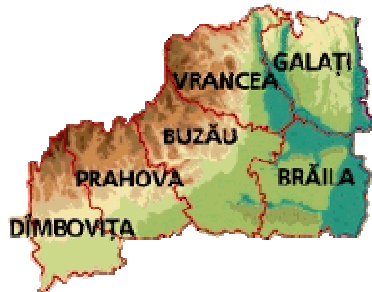
**Fig. 1. Geographical map with the relief types in the company's responsibility area**

Geographically, the responsibility area covered by the company includes all the types of relief, from plane, the Danube and other important rivers, to the hills and mountains up to 2500 m high. We supply power for 6 relatively important towns and various industrial activities, agriculture and tourism (fig.1).

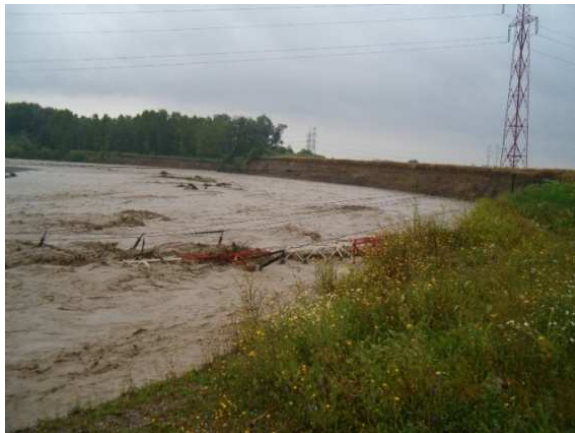
Fig. 4. 110 kV broken pillar fallen in Prahova river. The bank erosion caused by the abnormal water flow is visible

Figure 4 shows the picture of a 110 kV broken pillar, taken shortly after the floods. We can also see a pillar of 220 kV in danger due to the river bank erosion. Figure 3 and 10 present the network single-line diagram in normal conditions and after the floods.

Due to ground erosion, the foundation was destroyed and the both pillars collapsed in the end. A visual inspection of the network revealed also numerous minor deterioration which cannot be ignored on long term.

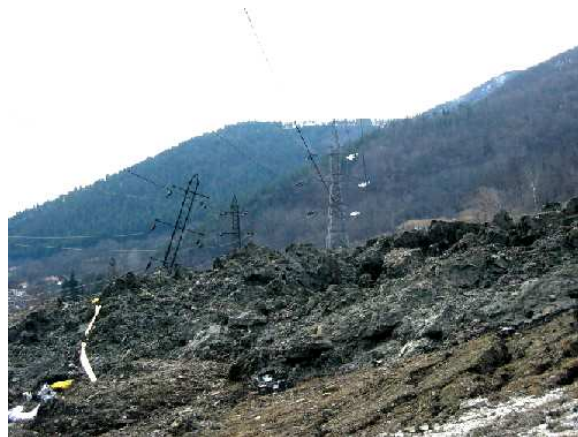
Fig. 5. Massive ground slide that damaged 110 kV and MV overhead lines

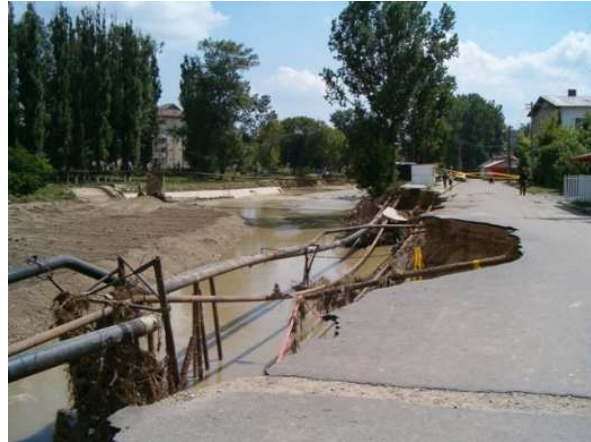
**Figure 6. Bank erosion with MV affected cables**

The solutions varied from temporary repair to long-time results in different technical approaches. One of the most complex problems, both in design, network building and operation, appeared in the cases of river crossings and power line parallel with river banks (Figure 6) or/and with other lines or utilities.

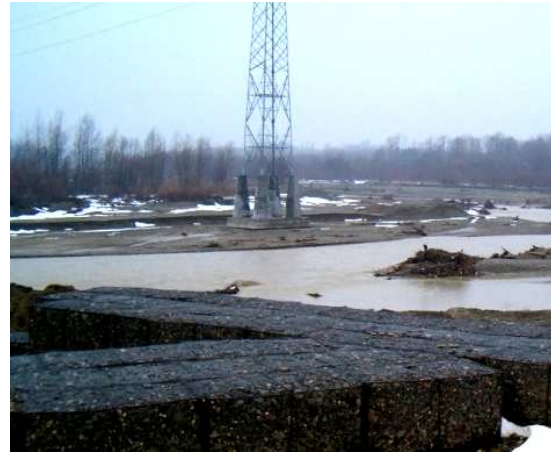
**Figure 8. Benoto piles and river bank consolidation**

The usual way to achieve a strong fundament in river beds for the power line pillars was to build a caisson, the depth being specified by a geological study (for example 10 m). A better solution offered by the designers, first time applied in our area, was the use of Benoto type drill piles (14 m depth). From technological point of view, the Benoto columns represent the best known type of drilled piles, allowing to reduce twice or four times the building period, at a lower price (Figure 8). Another solution tested, was the use of nine micro-piles, 9 m depth, for a 110 kV overhead line pillar. The micro-piles were not so effective as the Benoto piles, taking into account both the labour-time and the cost.

For the pillars foundation, in rivers bed, the Benoto piles proved optimal as building-time and cost-effectiveness, the caisson will be no longer put in work. The wooden piles are also reliable and cost-effective as a temporary solution.

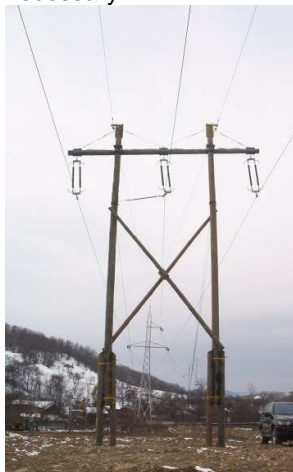
**Figure 9. 110 kV portal wooden pillar**

The 110 kV wood pillars were practically forgotten. After almost 40 years, the company and its partners designed, manufactured and used 110 kV portal wood pillars (Figure 9). The wood pillars proved to be reliable and cost-effective at least as temporary solution, so it will be applied again when necessary.
